# ANNUAL REPORT FOR 2008

**Unnamed Tributary to Briery Run Mitigation Site  
(Crescent Road Site)  
Lenoir County  
WBS Element 34501.4.1  
TIP No. R-2719 WM**

Prepared By:  
Natural Environment Unit & Roadside Environmental Unit  
North Carolina Department of Transportation  
November 2008

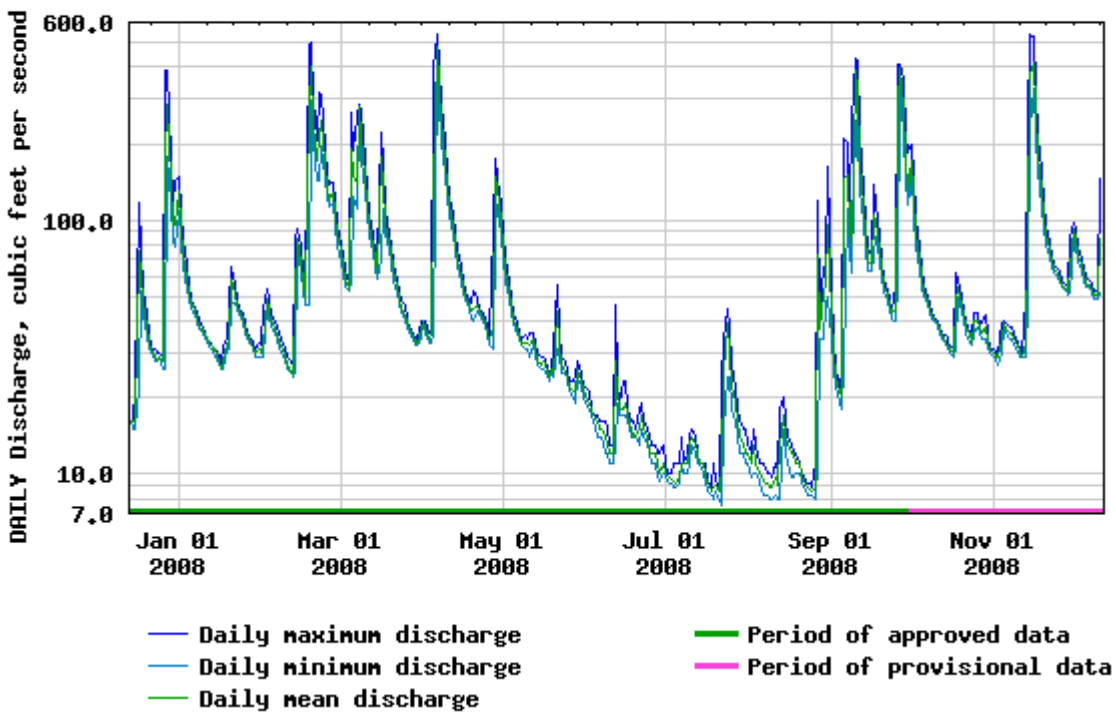
# USGS 0208925200 BEAR CREEK AT MAYS STORE, NC

The Bear Creek gage was utilized for this report since it is the smaller of the two gages (57.7 square-mile drainage area as compared to the 2,692 square-mile drainage area associated with the Neuse River). The Bear Creek gage more accurately reflects hydrology and precipitation in the project area. It is situated in USGS Hydrologic Unit 03020202. Datum of the gage is 50 feet above sea level NGVD29. Based on the drainage area associated with the gage, the correlated bankfull discharge according to the NC Coastal Plain Regional Curves (USACE, 2003) is between 200 and 500 cubic feet per second (cfs). A review of peak flows was conducted for the period between January 2008 and November 2008. According to the graph, there were approximately nine bankfull events documented during this monitoring period. This gage has met and exceeded the hydrological requirements in between 2001 and the current period. The USGS graphs depicting the peak flows occurring during 2008 is presented below.

Monitoring requirements state that at least two bankfull events must be documented through the five-year monitoring period. No surface water gages exist on the unnamed tributary or its receiving water, Briery Run. A review of known USGS surface water gages identified two gages within 10 miles (16 kilometers) of the mitigation site: one along the Neuse River in Kinston and one along Bear Creek near Mays Store, approximately 2.5 miles east of the Wayne and Lenoir County boundary.
